Innovative Materials and Advanced Technologies for a Sustainable Pavement Infrastructure

Jia-Liang Le, Principal Investigator

Department of Civil, Environmental, and Geo- Engineering
University of Minnesota

Research Project
Final Report 2021-18

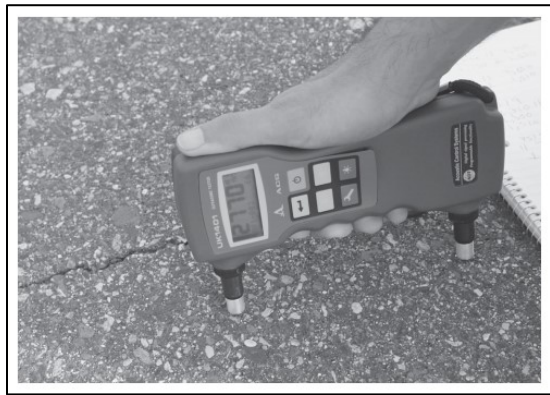
Figure 2.1: Ultrasonic tester UK1401. (Khazanovich *et. al.*, 2005)

An ultrasonic technology that has been used successfully for many years to determine cracking in concrete structures, provided an evaluation of distresses in asphalt concrete pavements through a simple procedure. (Khazanovich *et. al.*, 2005) The ultrasonic tester, a UK1401 (Figure 2.1), is used to obtain crack measurements in two directions: along and across each crack.

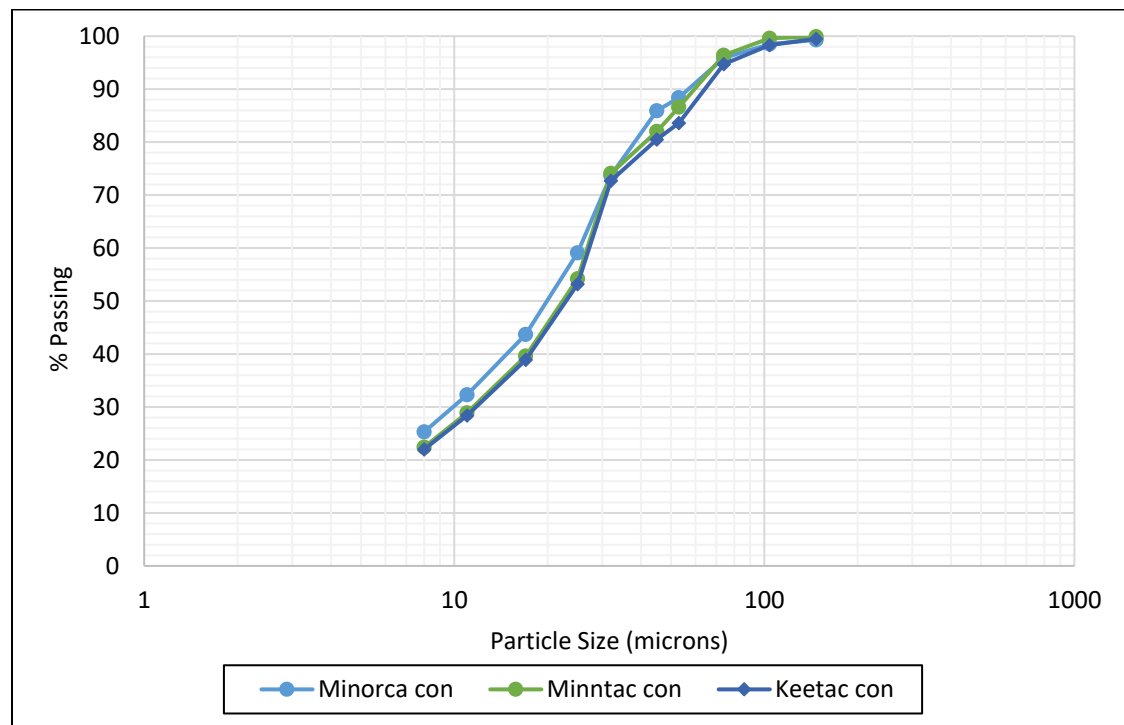
Figure 3.5: Taconite concentrate size distributions

Figure 3.5 shows the concentrate size distributions for the three operations mentioned above.

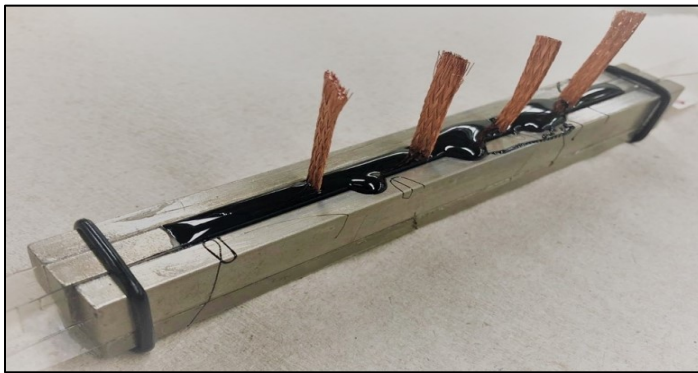
Figure 4.3: Sample preparation: beam molds with four copper electrodes.

Similar to Chapter 3, the electrical conductivity was measured by using a four-probe method. The mix was poured into the beam molds with four copper electrodes, as shown in Figure 4.3.
